Potential for Tree Damage Due to Glenwood Hills Reservoir 2 Access Road Construction Project

Joran Viers, Senior Partner
Root to Shoot Urban Forestry Inc
7/20/2021

Situation Statement and Preliminary Observations

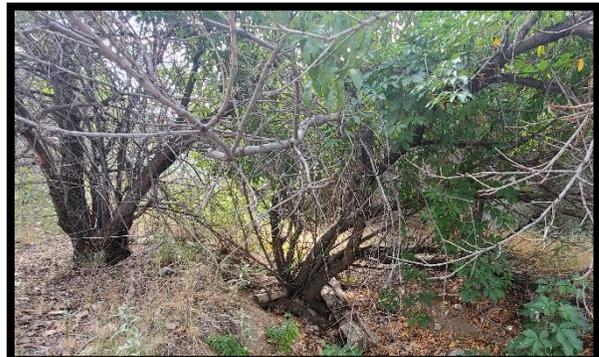
1. Peach tree: desirable, 3 main stems at 6" diameter or less, 12 feet tall. Good condition; sits astride the drainage and its roots likely help stabilize same (see Image 5). Tree may be outside of area impacted, but it is very close and may be damaged. If a decision is made to extend the grub and clear area, the tree may need to be removed. Alternatively, if outside the work zone, it may suffer minimal to no negative impact and not need mitigation. Prune low dead and in-the-way branches to allow free access from parking area to manhole cover.

Image 5: peach tree straddling arroyo bed (middle) with small Russian olive on left side.

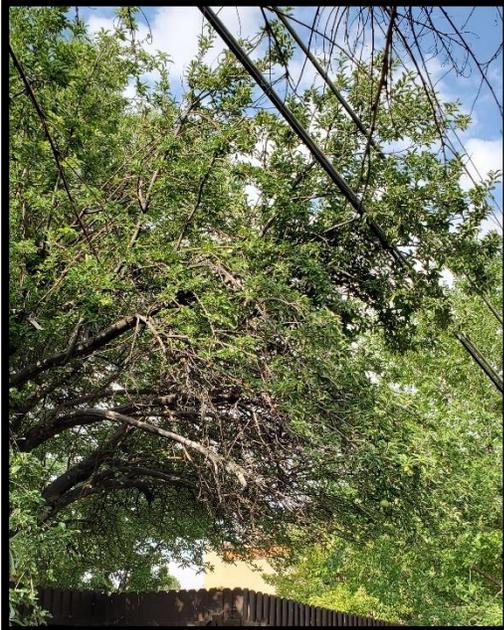
2. Russian olive: undesirable (except by wildlife), 2 main stems at 8" or less DBH, 20 feet tall. Good condition, in grub and clean area so will be cut down. Growing into power lines, may require PNM contractor to do initial pruning to clear the wires prior to contractor completing removal.
3. Apple: desirable, south side of wall on private property, approximately 14"DBH, 15 feet tall. Some of tree's north side root zone is in the area slated for grubbing and clearing. With care, the area can be minimally impacted that close to the fence. Continuing and perhaps augmenting irrigation on the private side is best mitigation option. Tree should have north-side branches pruned back from power line (Image 6).

Image 6: prune dead and living branches back from power lines using reduction cuts to existing side branches well outside powerlines.

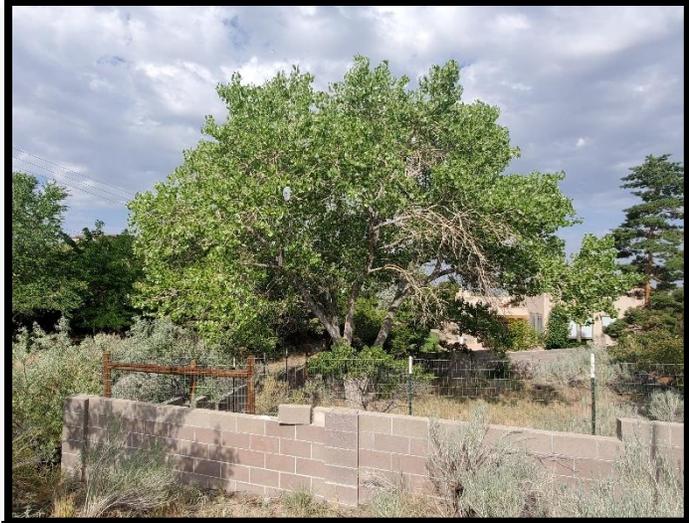
Image 7: Rio Grande cottonwood showing relatively healthy canopy, though dieback has begun on the north side of the tree due to lack of irrigation on that side.

4. Rio Grande cottonwood: desirable but out of place, 24" DBH, 25+ feet tall. In good condition though canopy is thin for species, indicating ongoing stress (lack of high soil moisture preferred by riparian trees like cottonwood). Much of this tree's root zone is outside the construction area but many roots will have grown down into and along the arroyo bed. All efforts should be made to avoid traffic, disturbance, and soil compaction on the north side of the arroyo adjacent to this tree. Additionally, the homeowner should begin regular and substantial irrigation on their side of the wall to (hopefully) prevent this tree sliding further into drought stress and perhaps going into decline and death (Image 7).

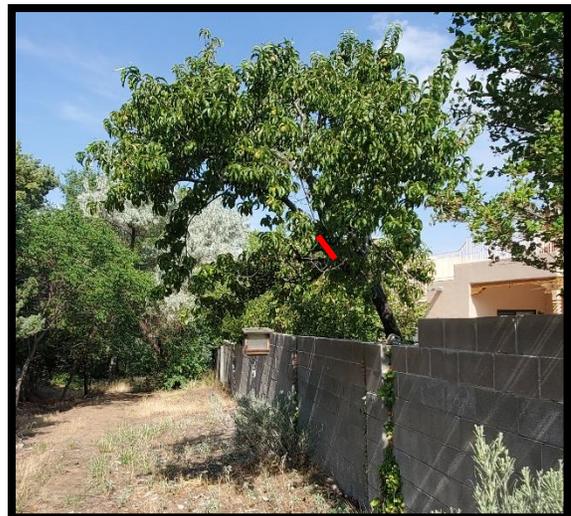
5. Peach: desirable, 5" DBH, 12 feet tall, good condition. Growing just on north side of north easement wall. Minimal root zone damage expected. Continued care and irrigation on north side of wall will mitigate any damage. Prune low branch with one 2" removal cut. (Image 8, on right: red line shows approximate location of pruning cut. Branch to remove has bird feeder hanging from it.)

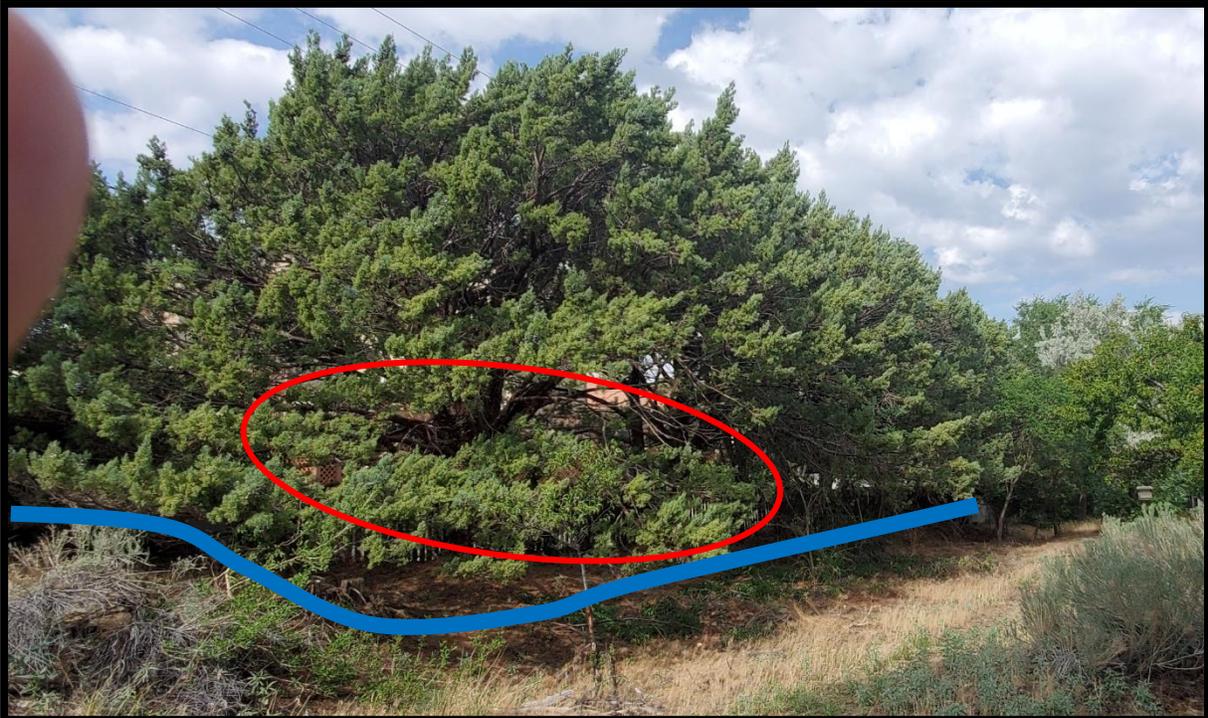
6. Arizona cypress: desirable, 24" DBH, 20+ feet tall. Good condition. Areas just outside CRZ

and well within root zone will be impacted, on two sides (north side and east side). Construction plans do place the area to be grubbed and cleaned beyond the canopy, which at least preserves the CRZ. Water harvesting channel exists coming from uphill neighbor's back yard, providing additional water to this tree and the other 7 in the tight row (Image 9). This feature needs to be recognized and preserved. I have concerns for the permeability of the arroyo bottom post-construction, as that water harvesting feature feeds right into the bottom. Mitigate root damage through increased irrigation on south side of trees. Prune low branches on north side of canopy for vehicular clearance; reduction cuts may be applicable but those may need to be complete removal cuts (Image 9).

Image 9: line of Arizona cypress trees. Blue line indicates approximate path of water harvested from neighbor's property. Red oval indicates area where some pruning may be needed.

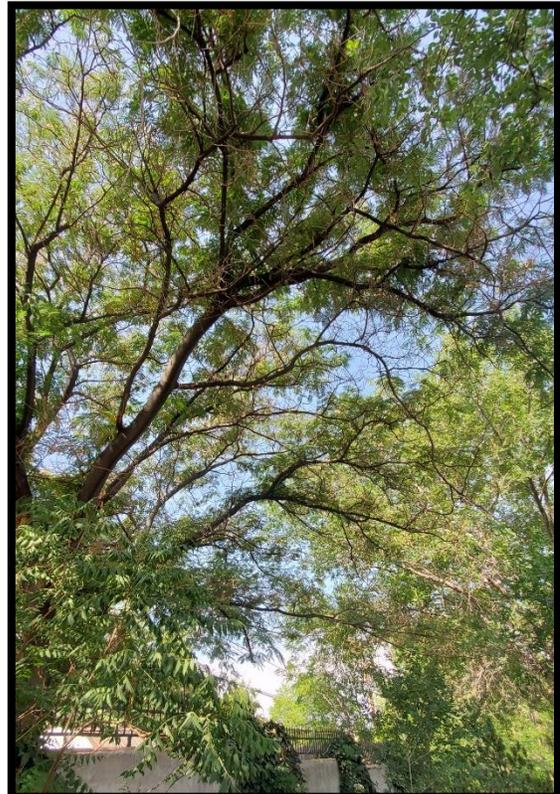
15. Mimosa: desirable, 16" DBH, 25 feet tall, fair condition. large for species, showing signs of water stress already (dead branches, thin canopy; see Image 10). Roadway will touch outer part of root zone; damage should be minimal (***tree is already showing decline and may be/become infected with verticillium wilt***). If owner wants to keep tree they will need to irrigate appropriately. No pruning required for clearance.

Image 10: mimosa tree showing thin canopy, dead branches due to ongoing water stress.

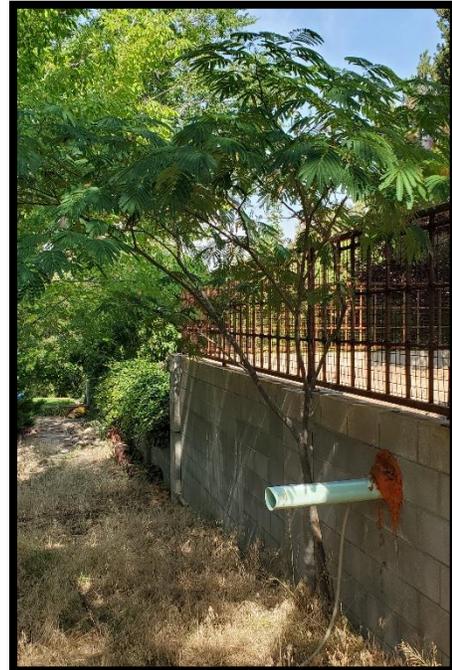
15.a. Mimosa sapling: desirable species, bad location – directly north of tree 15, growing very close to cinderblock wall, should be removed to prevent infrastructure damage; it is also growing with a strong lean to south, putting it on growth path into roadway space (Image 11).

Image 11: mimosa sapling to be removed due to proximity to wall.

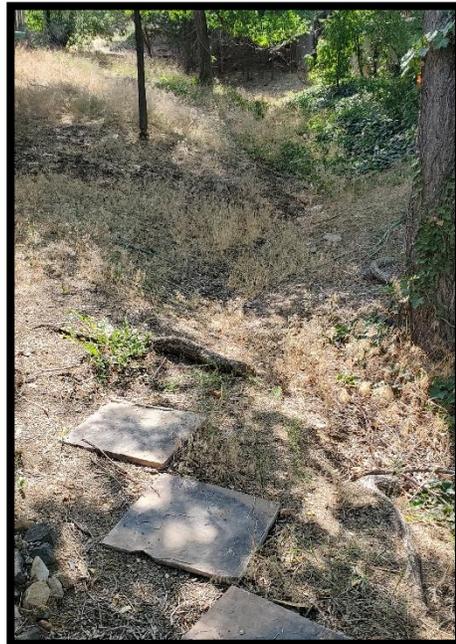
16. Siberian elm: neutral, 16" DBH, 45+ feet tall, good condition. Species is very invasive but grows well in our difficult environment. This tree has been selected to remain but will suffer serious, potentially catastrophic root zone damage both at roadway (completely violates CRZ, large surface roots present now, see image 12) and around outflow area (due to extensive cutting and grade reduction below/around outflow). Damage to large size and large number of roots will almost certainly lead to canopy decline due to lack of water, internal decay due to wounds on root system, and quite possibly to destabilization of the entire tree – wind fall chances will increase dramatically with close root damage. Given the closeness of root damage to the trunk, this tree is one that may present a stem failure potential several years post-construction, when root decay has advanced enough to destabilize the stem. Consider removal.

Image 12: Siberian elm roots at surface. Roadway to go right next to tree trunk and over these roots, damaging them severely. Roadway will impact drainage running adjacent to tree trunk.

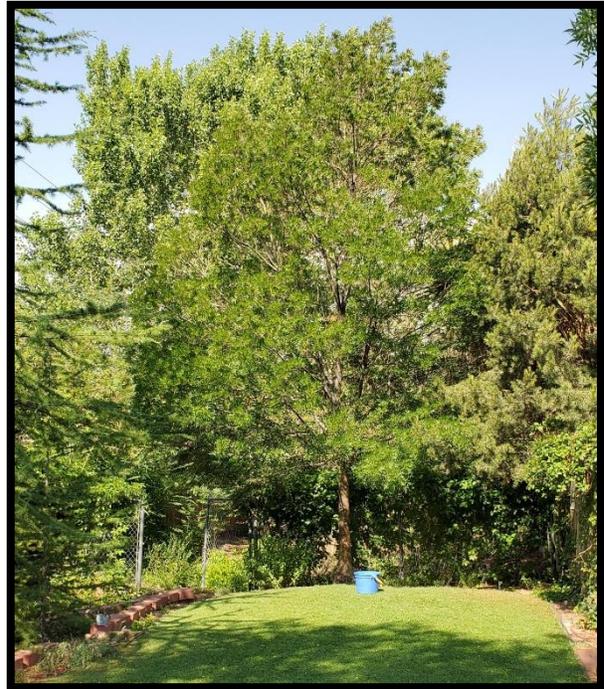
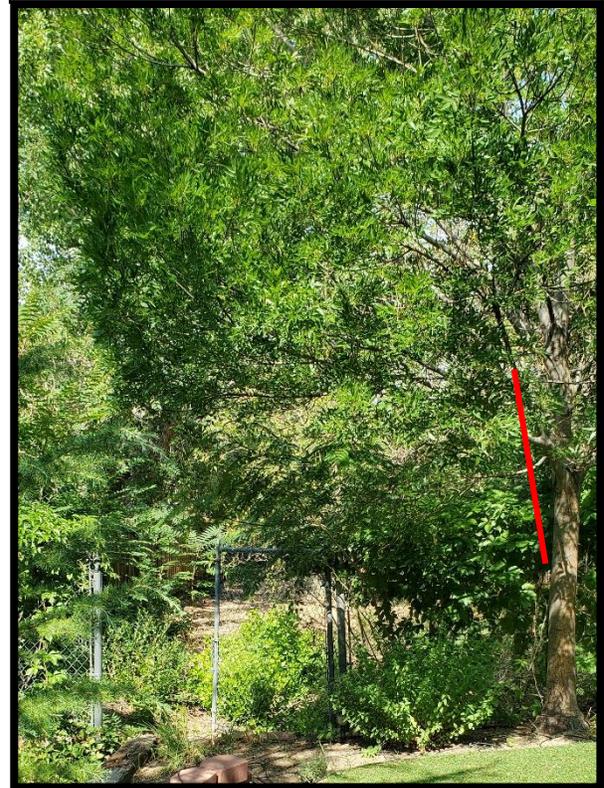
18. Raywood ash: desirable, 6" DBH, 25 feet tall, good condition. This tree will suffer severe root zone damage within the CRZ on the south side. There will be significant dieback of branches on that side, and tree destabilization is a strong possibility due to proximity of root cuts that are very likely to occur (Images 13 &

14). The entire drainage and hydrology on the adjacent south side of the tree will be changed by the construction work. On the positive side, neighbor who planted the tree has been irrigating regularly in areas that will not be impacted by the work, including under the artificial turf. This turf product should be removed, and drip tubing installed such that the footprint of applied irrigation covers a large area east of the tree. This should then be covered up deeply with wood chips, 8-10 inches deep. That will protect the lines and the soil during construction. Post-construction, the wood chips can be spread out to a thinner, 3-inch-deep layer around the root zone to both east and west sides.

Images 13 (above) & 14 (below): Raywood ash that will have massive root damage to south side. Clearance pruning will be required approximately along the red line.

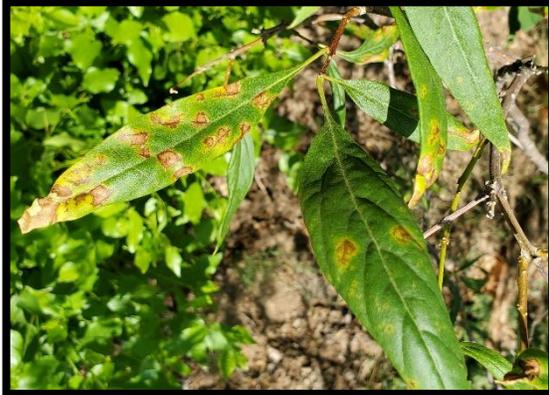
20. Chitalpa: neutral – once a popular ornamental, no longer available in the local marketplace due to inevitable infection by *Xylella fastidiosa*, a plasmid pathogen that causes summer leaf scorch. 8" DBH, 20 feet tall. Tree is in poor condition due to *Xylella* infection (see Image 15). Neighbor wants to keep tree despite chronic illness. There will be significant root zone impact on south side of tree, including within the CRZ. There are significant clearance pruning needs on that side of the tree as well (which to some uncertain degree balances the loss of

Image 15, top left: chitalpa leaves showing summer leaf scorch symptoms due to Xylella infection.

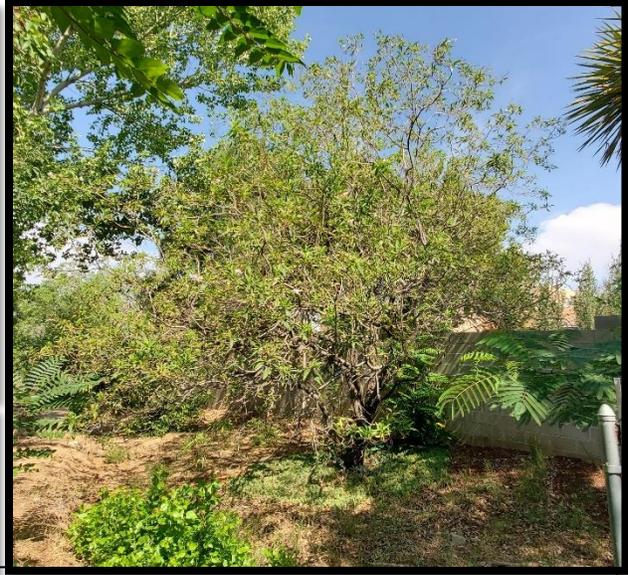
Image 16, above: whole tree showing thin canopy and discoloration due to Xylella; tree will likely continue declining.

roots on that side): one 4” removal cut of low branch on southwest side, 3 thinning cuts of about 1.5 inches, and 3 reduction cuts to upright laterals (Images 16 & 17).

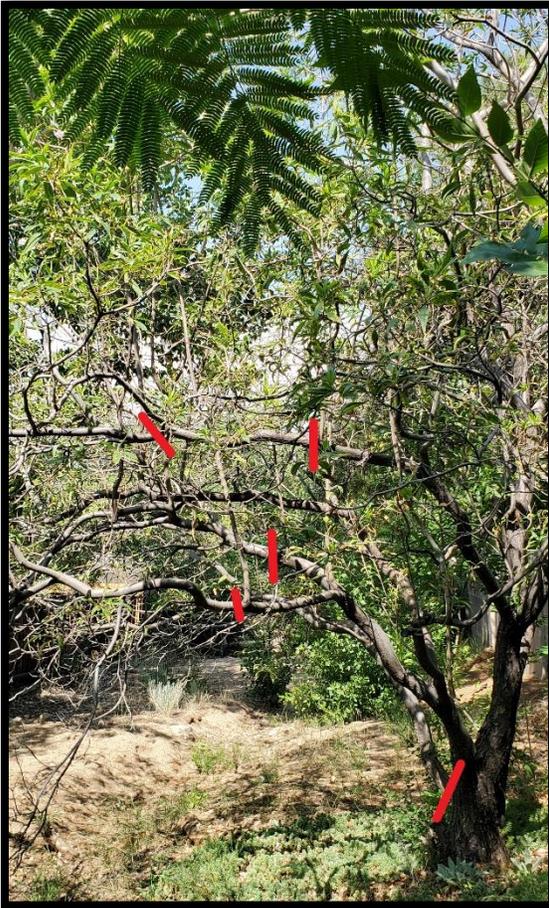
Image 17, left: placement of some of the pruning cuts that need to be done for clearance.

NOTE: as it is very difficult to illustrate on a photo exactly where cuts should be made, I am willing to meet with crew onsite to direct.

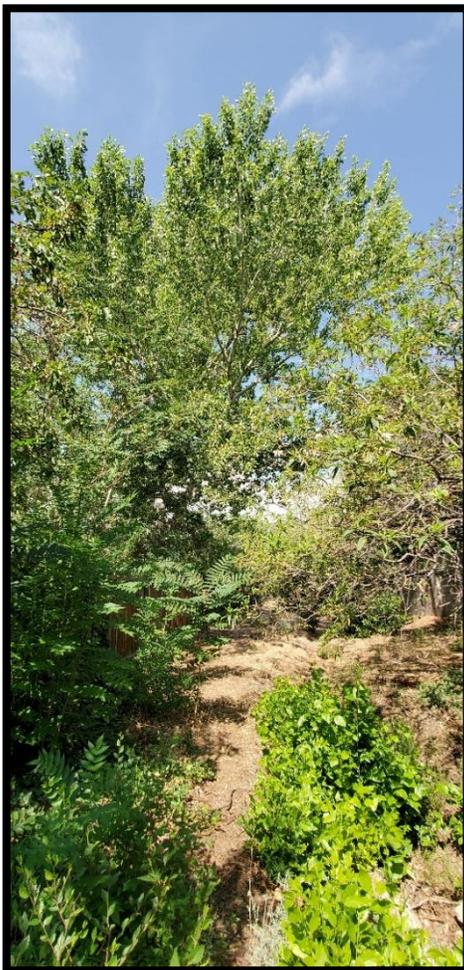
23. Hybrid poplar: neutral (fast growing, quick shade; high water, short lifespan, prone to large branch failure), 26" DBH, 65+ feet tall. Good condition, large tree with multiple long, tall branches typical of species (Image 18). Root zone damage to this tree will be catastrophic: root sprouts coming up at least 50' away in arroyo and multiple large roots in and crossing arroyo, up to 8" diameter (Image 19). No irrigation on south side of tree in owner's yard, so this tree gets almost all its water from the arroyo and the neighboring yards on the north side of the arroyo. Many large, long roots will be cut, buried, compacted, broken and otherwise damaged. Poplar trees (cottonwood relative) do NOT protect their wood well against decay or disease organisms, and once the root damage is done, the tree will quickly decline, die, and begin falling apart. This may take a long as 5-7 years but may be quicker.

Image 18, left: hybrid poplar in background, root sprouts growing from 3" roots in foreground, near Tree #18.

I STRONGLY RECOMMEND REMOVAL OF THIS TREE AT THE START OF THE PROJECT. IT WILL BE MUCH MORE COMPLICATED IF LEFT TO DECLINE AND THEN DEALT WITH. IF THE NEIGHBOR IS NOT AGREEABLE, UNDERSTAND THAT COURT PRECEDENT ALLOWS EASEMENT OWNER TO ADDRESS ANY LIMBS OR BRANCHES ON THEIR SIDE OF BOUNDRY.

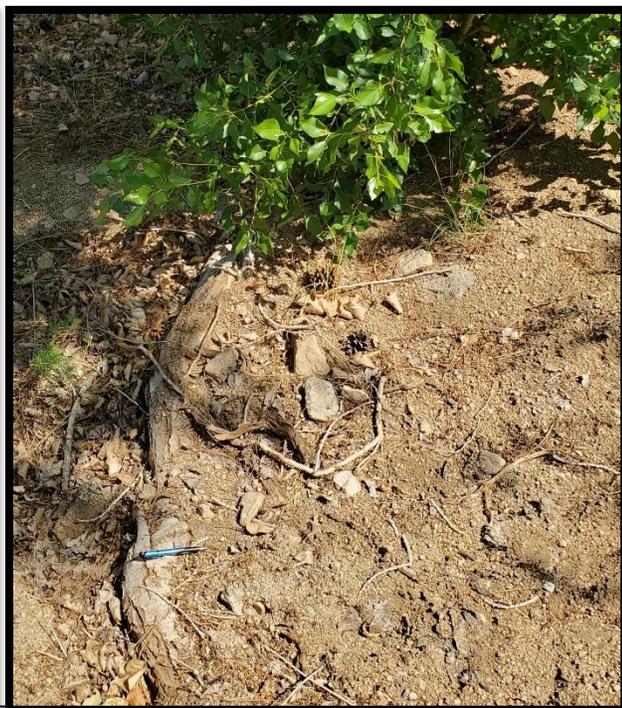
Image 19, above: large surfacing root crossing channel and growing to neighbor's property. Blue pen for scale.

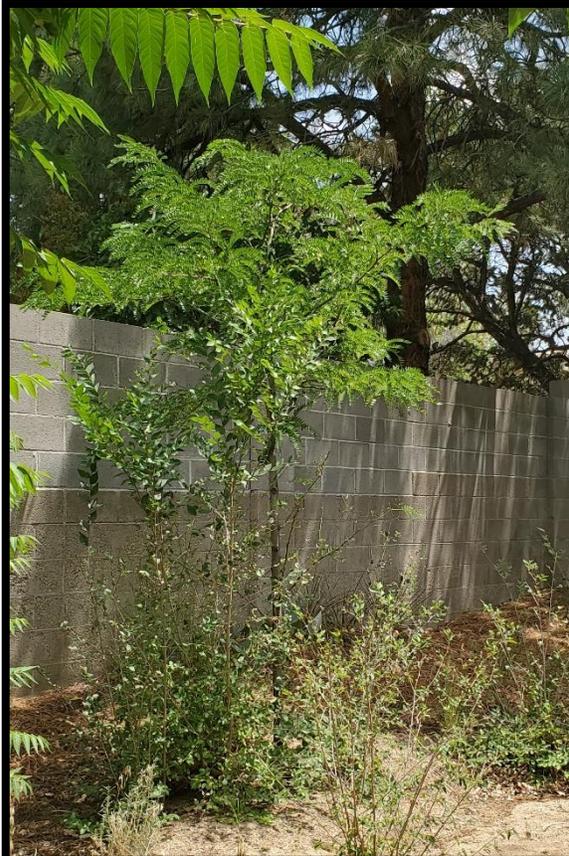
24. Honeylocust: desirable, 2” DBH, 8 feet tall. Good condition. With care, should not suffer any significant root zone disturbance. Mitigation is not needed, though neighbor (who planted tree) should increase the area being irrigated and the amount of water applied (Image 20).
25. Pinyon pine: desirable, 16” DBH, 20 feet tall. Good condition. Minimal root zone damage expected, minimal impact. Pruning might be done on one long, low branch – one 3.5” reduction cut on lower limb (Image 21).

Image 20: young honeylocust, well out of work zone.

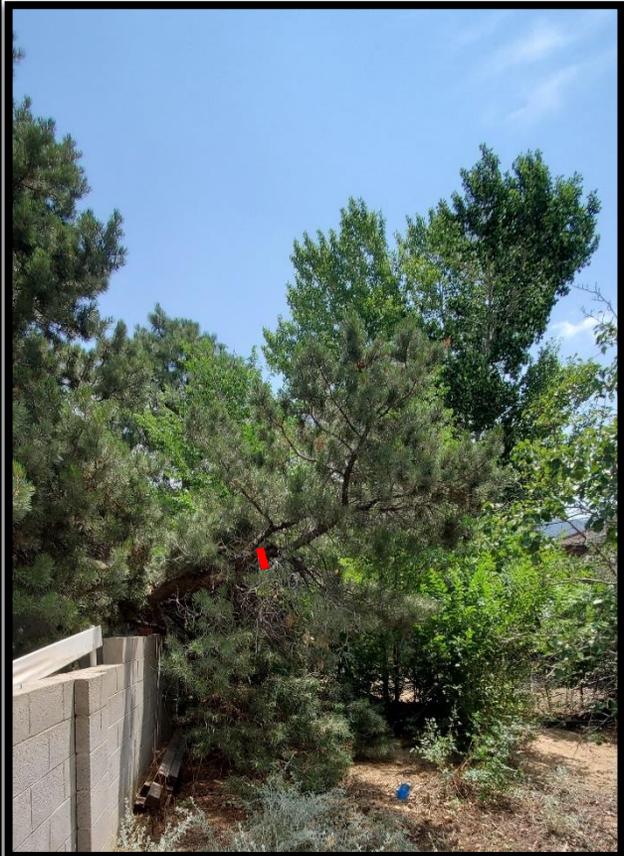
Image 21: pruning cut could be made at red line, if needed.

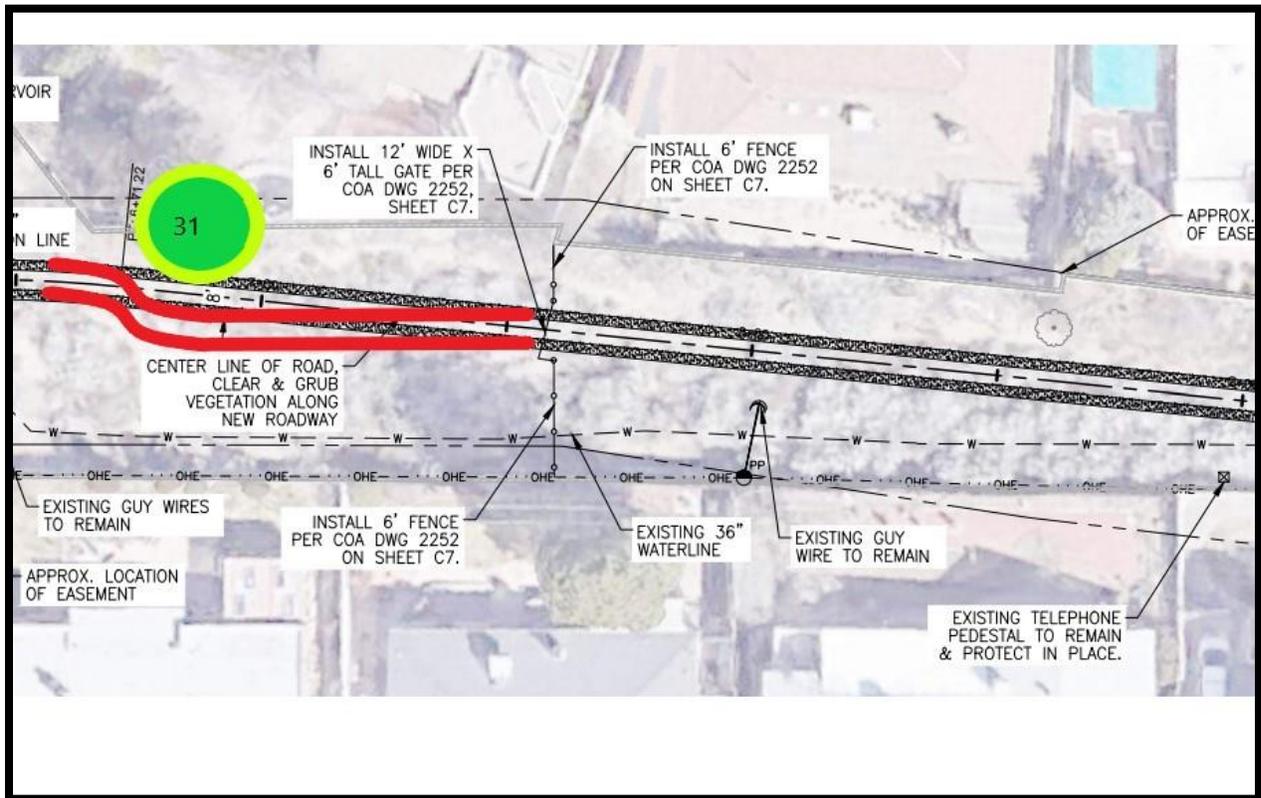
Image 4: Numbered Tree 31

28. Siberian elm: 7" DBH, 25 feet tall, fair to good condition. Situation same as tree above. Prune 3 low dead branches on north side of tree.
29. Siberian elm: 9" DBH, 20 feet tall, good condition. Situation same as tree above. Prune one 3" removal and above that one 1" thinning cut.
30. Ponderosa pine: desirable, 14" DBH, 30 feet tall, fair condition. This tree is showing some drought stress through browning needle tips. Does not appear to be irrigated on owner's side. Road will cut through moist part of root zone but outside CRZ. Mitigate by irrigating on both sides of boundary wall.
31. Ponderosa pine: desirable, 18" DBH, 45 feet tall, good condition. Road as shown will cut across edge of CRZ, with some but not strong negative impacts. Mitigate by swinging road out farther from the drip line/CRZ, as shown by red lines on Image 4, and with continued irrigation by owner.
